Aprisa **FE**

Software Release Notes

Version 1.2.5a

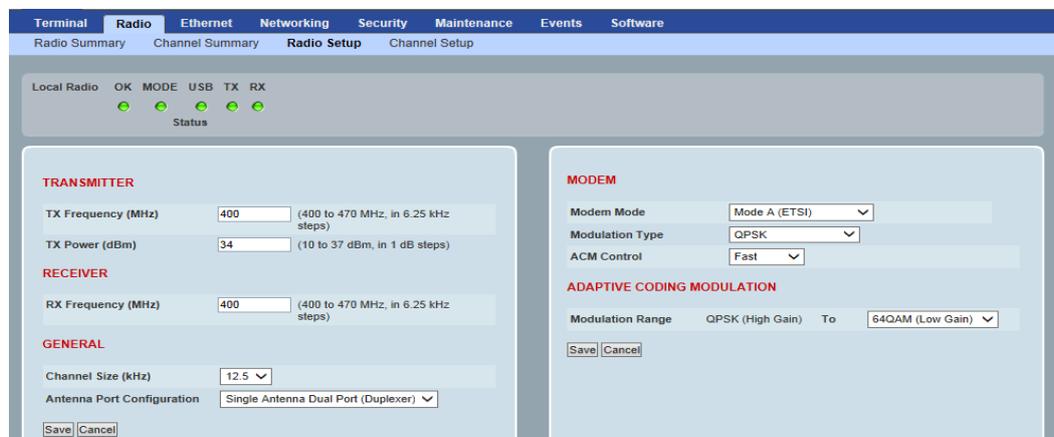
In software version 1.2.5, this function is now called Modem Mode and is in the Radio > Radio Setup screen. This was to bring together all the radio settings on one screen.

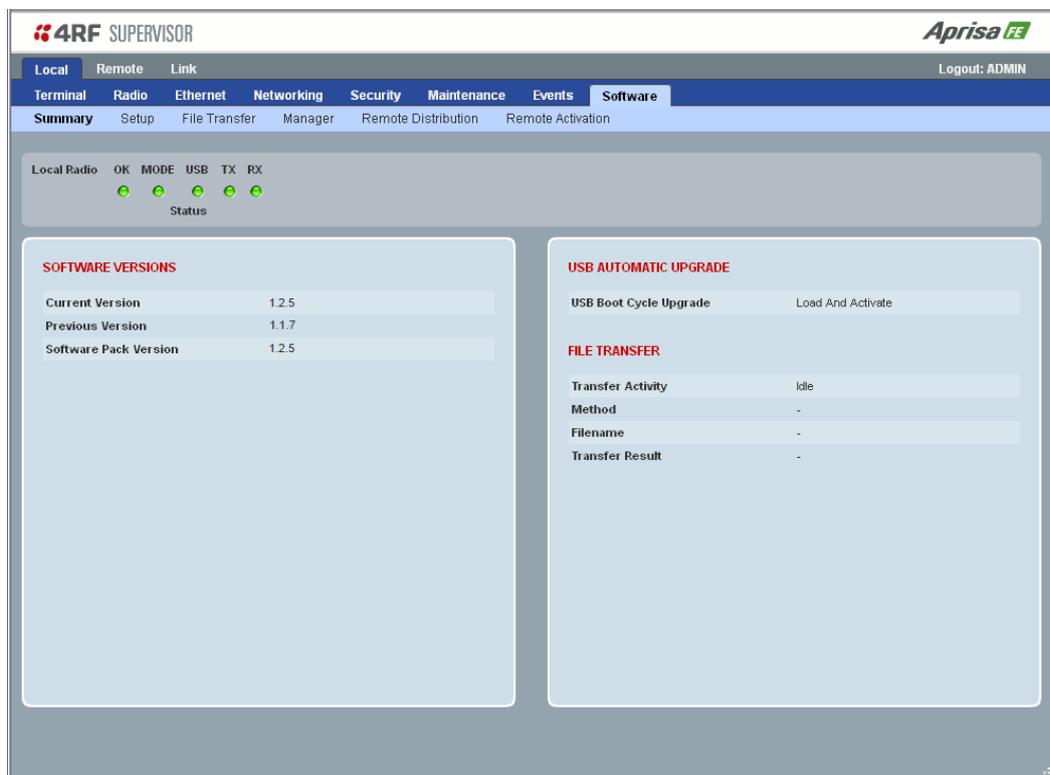
.
5. Activate the software on the radio (see SuperVisor > Software > Manager). This can take up to a few minutes.
6. The new software version can be verified with SuperVisor > Software > Summary Current Version.

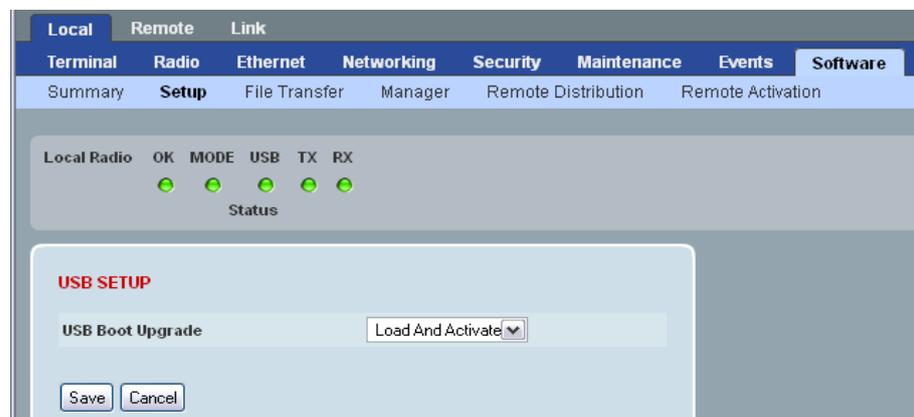
Check that the SuperVisor USB Boot Upgrade setting is set to 'Load and Activate'.

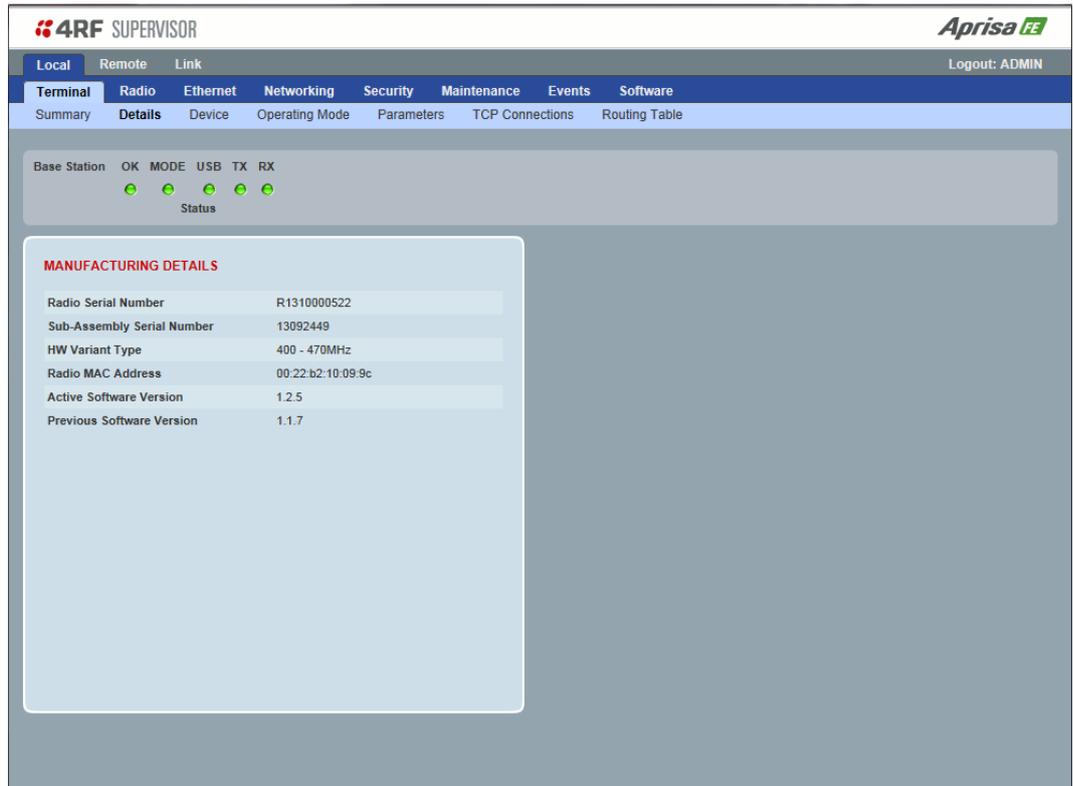
Login in to SuperVisor and select Terminal > Details to view the Active and Previous software versions.

The screenshot displays the 4RF SUPERVISOR web interface. At the top, there is a navigation bar with 'Local', 'Remote', and 'Link' tabs. Below this is a main menu with categories: Terminal, Radio, Ethernet, Networking, Security, Maintenance, Events, and Software. Under the 'Terminal' category, there are sub-items: Summary, Details, Device, Operating Mode, Parameters, TCP Connections, and Routing Table. The 'Details' sub-item is selected. The interface shows a 'Base Station' status section with indicators for OK, MODE, USB, TX, and RX, all of which are green. Below this is a 'MANUFACTURING DETAILS' section with the following information:

MANUFACTURING DETAILS	
Radio Serial Number	R1310000522
Sub-Assembly Serial Number	13092449
HW Variant Type	400 - 470MHz
Radio MAC Address	00:22:b2:10:09:9c
Active Software Version	1.2.5
Previous Software Version	1.1.7
