Aprisa **SR**

Software Release Notes

Version 1.1.0

September 2010

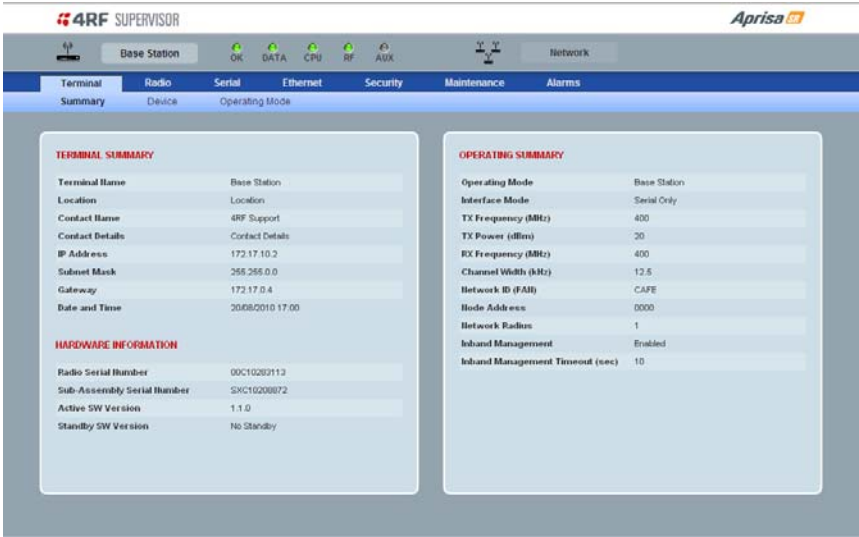
View the Software Version

To view the uploaded software version:

Select Terminal Settings > Terminal > Summary

If USB Upgrade setting is set to 'enabled', then the version of software uploaded will be displayed in 'Active SW Version' field.

If USB upgrade setting is set to 'Authenticate', then the version of software uploaded will be displayed in 'Standby SW Version' field.
