Aprisa **XE**

Software Release Notes

Version 8.8.55

August 2015

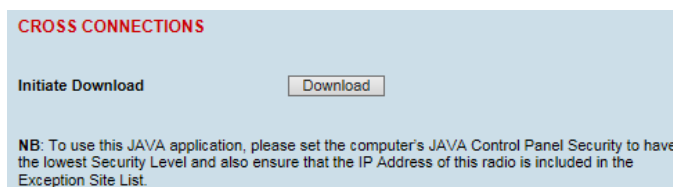
The Cross Connect and the Alarm History Download are both Java applications but do not have security issues. These applications will operate correctly with Java versions 1.6, 1.7 and 1.8.

When the application is requested from SuperVisor, the following warning message will advise the Java Security settings required;
